## SITE OBSERVATION REPORT

Project: 12100	Project Name: Lakeside Meadows Subdivision - Buncombe County Tri-Annual Storm Water Inspection	Observer: AD
Date: 2021-07-21	Weather: Sunny 75F	Time: 9:30 AM

- Buncombe County Tax Map, Pin No#: 9742-15-4866 DB 5146 PG 1890
- Buncombe County Operations and Maintenance Agreement
- Permit Number: STW2014-00008

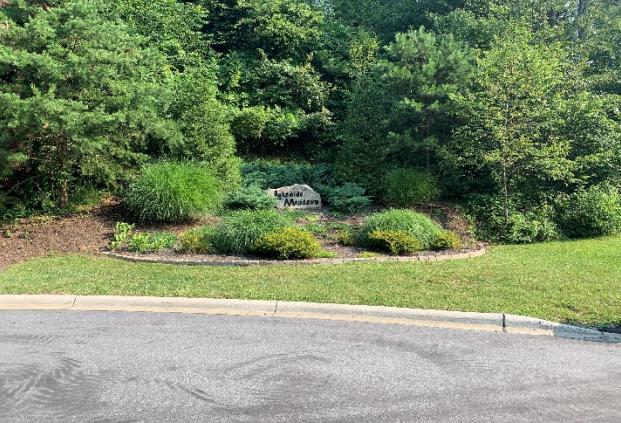
Picture 1	Notes

Picture 1 shows the entrance to Lakeside Meadows. A paved road curves to the right, bordered by a concrete curb. In the center of the curb is a small, rectangular stone sign that reads 'Lakeside Meadows'. The area is landscaped with green grass, shrubs, and trees.	Entrance to Lakeside Meadows.
Picture 2	Notes

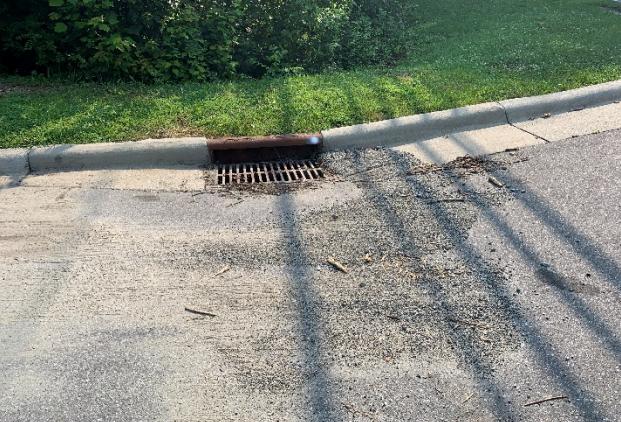
Picture 2 shows a typical curb inlet. A paved road with a concrete curb on the right side has a metal grate with a mesh screen attached to the curb. The area is landscaped with green grass and trees.	Typical curb inlet. All onsite curb inlets appear to be in overall good condition and functioning as intended. Owner should keep road(s) clean and avoid allowing contamination of storm water system with debris.
Picture 3	Notes

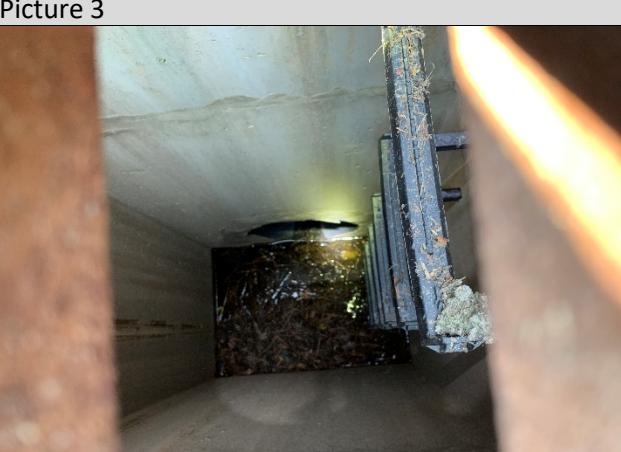
Picture 3 shows the interior of a storm water structure. The view is through a metal grate into a dark, enclosed space. The walls are made of concrete, and there is a light fixture at the end of the structure. The interior appears to be filled with debris and water.	Inside of storm water structure shown in picture #2 (above).

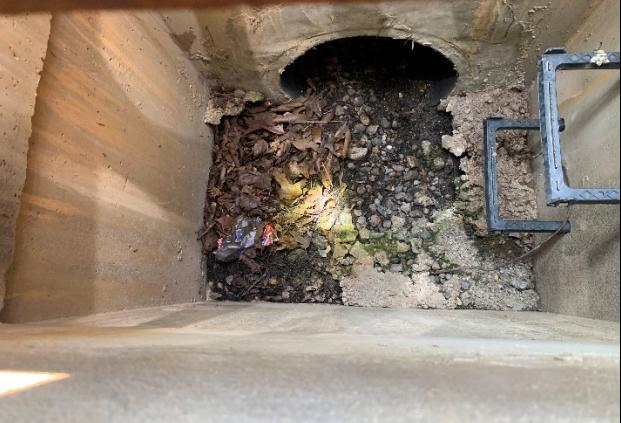
Picture 4	Notes

<p>Inside of onsite storm water structure.</p> <p>Owner should clean debris from within storm water structure.</p> <p>Keeping the structure(s) clean will ensure system continues to function as intended.</p> <p>Structure appears to be functioning as intended.</p>
Picture 5	Notes

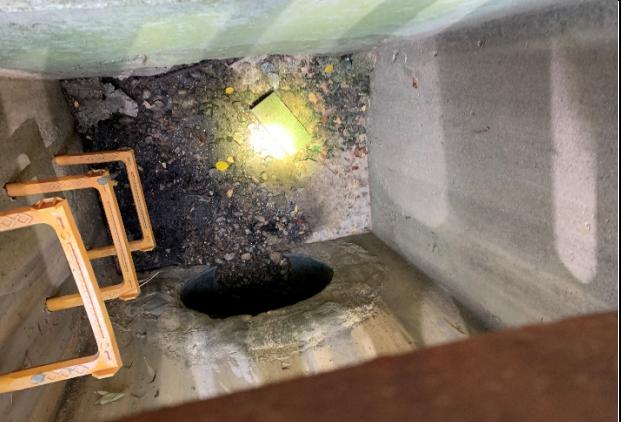
<p>Inside of onsite storm water structure.</p> <p>Owner should clean debris from within storm water structure.</p> <p>Keeping the structure(s) clean will ensure system continues to function as intended.</p> <p>Structure appears to be functioning as intended.</p>
Picture 6	Notes

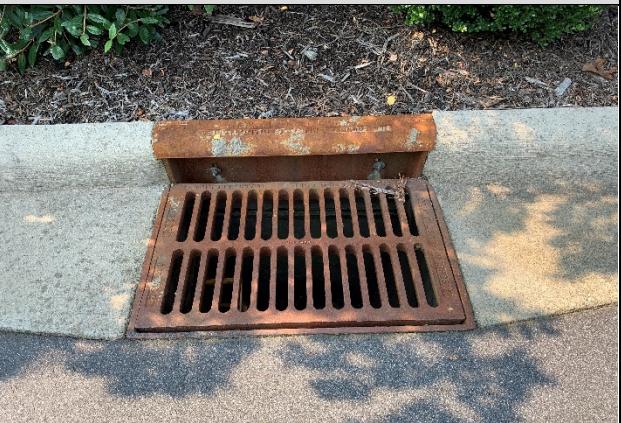
<p>Typical curb inlet.</p> <p>All onsite curb inlets appear to be in overall good condition and functioning as intended.</p>

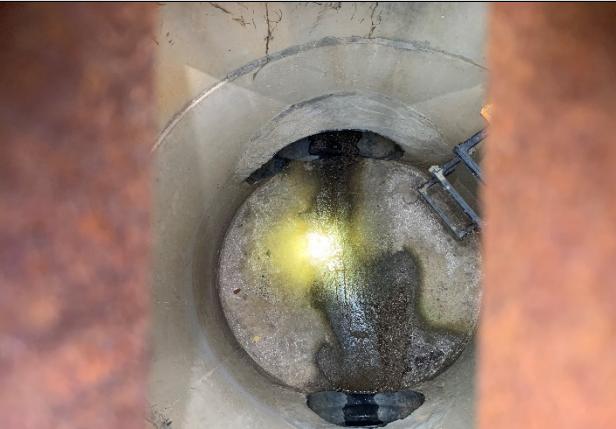
Picture 7	Notes

<p>Inside of onsite storm water structure. Structure appears to be functioning as intended.</p>
Picture 8	Notes

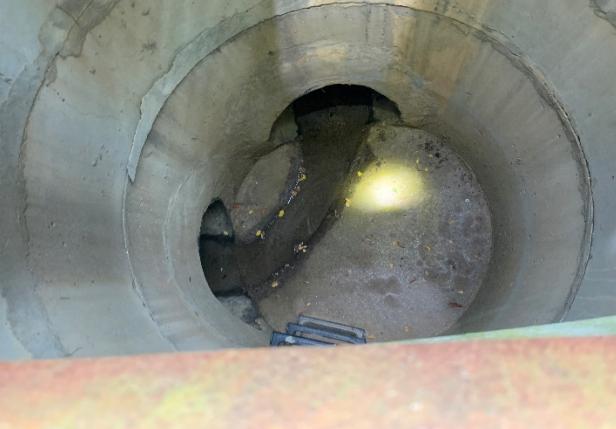
<p>Inside of onsite storm water structure. Structure appears to be functioning as intended.</p>
Picture 9	Notes

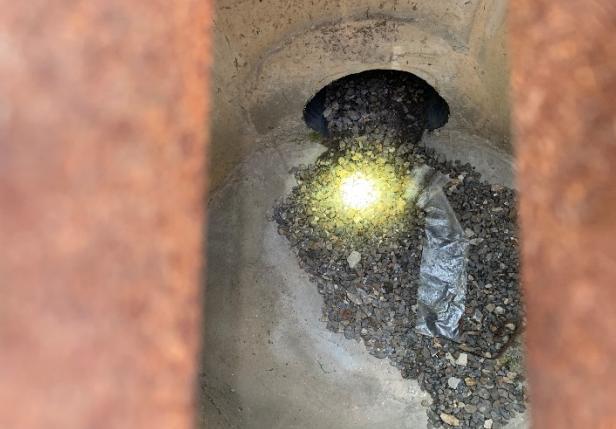
<p>Inside of onsite storm water structure. Owner should clean debris from within storm water structure. Keeping the structure(s) clean will ensure system continues to function as intended. Structure appears to be functioning as intended.</p>

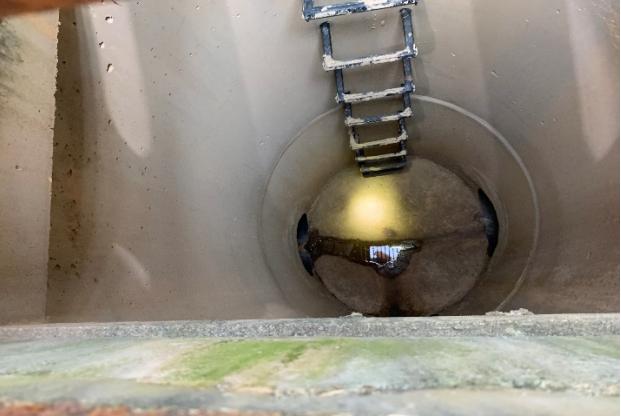
Picture 10	Notes

<p>Inside of onsite storm water structure. Structure appears to be functioning as intended.</p>
Picture 11	Notes

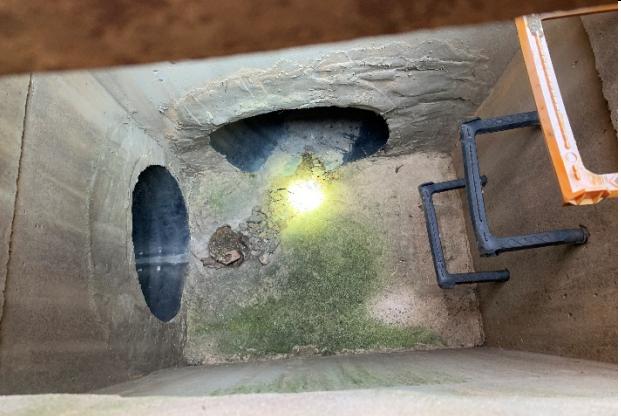
<p>Inside of onsite storm water structure. Structure appears to be functioning as intended.</p>
Picture 12	Notes

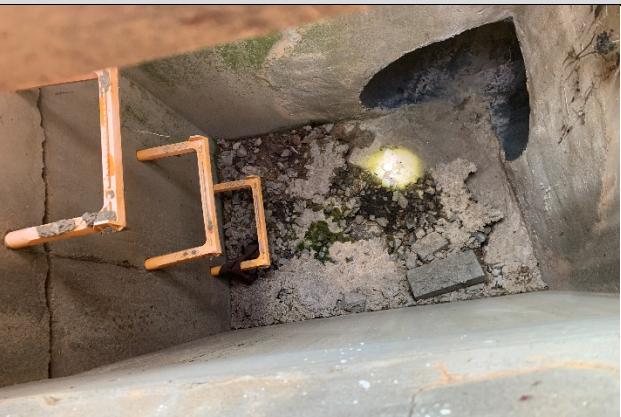
<p>Inside of onsite storm water structure. Owner should clean debris from within storm water structure. Keeping the structure(s) clean will ensure system continues to function as intended. Structure appears to be functioning as intended.</p>

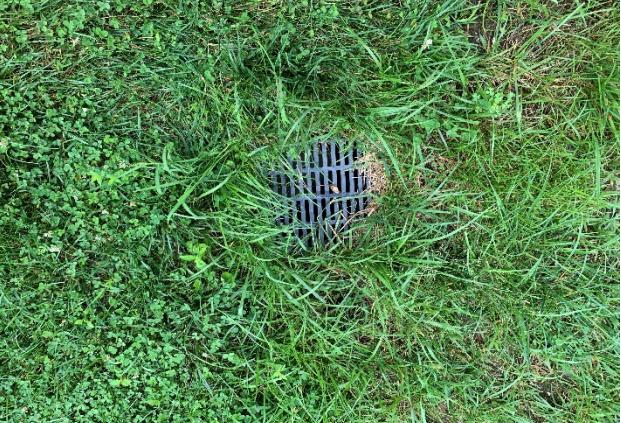
Picture 13	Notes

<p>Typical yard inlet.</p> <p>Yard inlet appears to be in overall good condition and functioning as intended.</p> <p>Owner should keep grate unobstructed and free of debris to ensure future proper operation of system.</p>
Picture 14	Notes

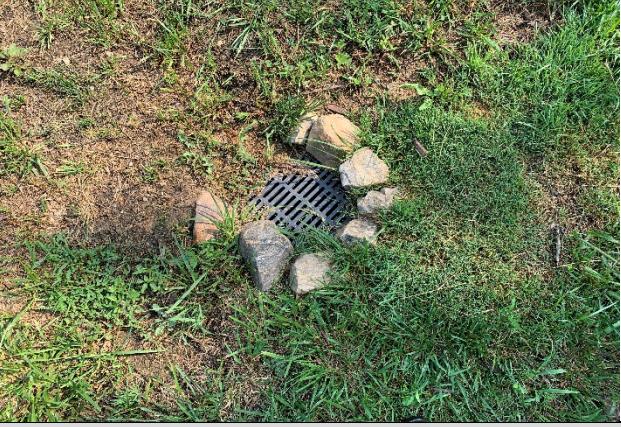
<p>Typical yard inlet.</p> <p>Yard inlet appears to be in overall good condition and functioning as intended.</p> <p>Owner should keep grate unobstructed and free of debris to ensure future proper operation of system.</p>
Picture 15	Notes

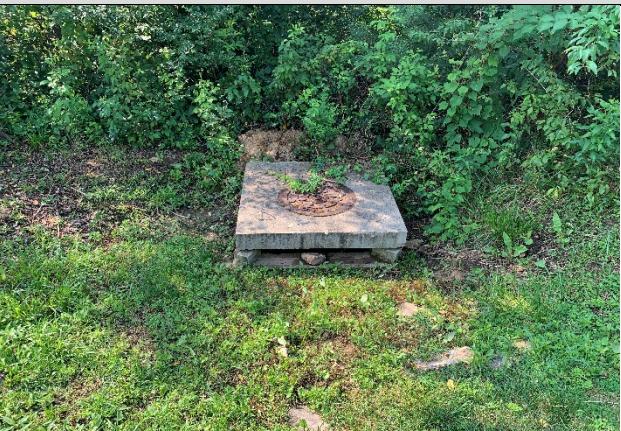
<p>Typical open throat structure.</p> <p>Structure appears to be in overall good condition and functioning as intended.</p> <p>Owner should keep throat unobstructed and free of debris to ensure future proper operation of system.</p>

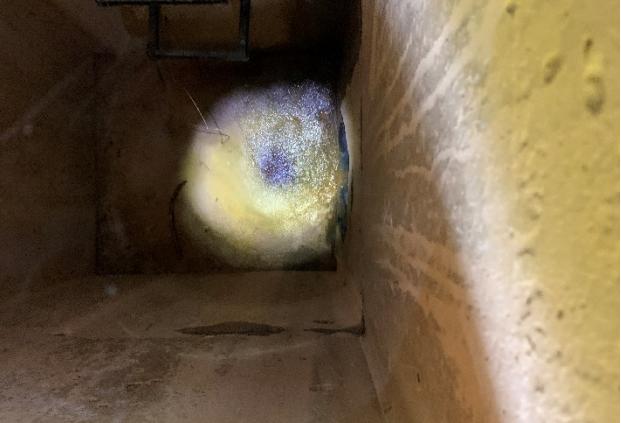
Picture 16	Notes

Picture 16 shows the interior of an open throat structure. The walls are made of a light-colored, textured material, possibly concrete or metal. Light is coming from the top left, creating a bright spot where water is falling or flowing. The floor is a darker, mottled color.	<p>Inside view of open throat structure shown in picture #15 (above).</p> <p>Structure appears to be in overall good condition and functioning as intended.</p>
Picture 17	Notes

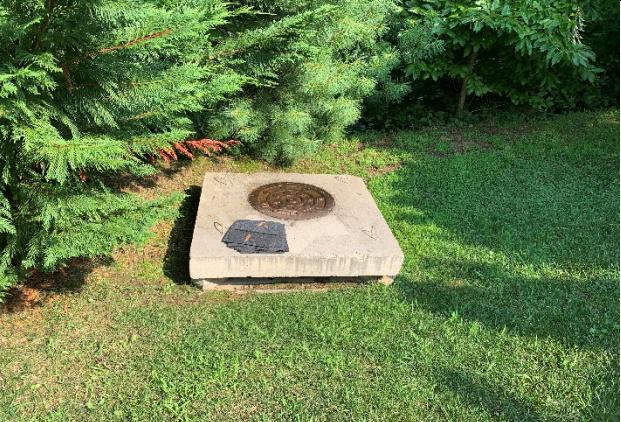
Picture 17 shows a typical open throat structure in a yard. It consists of a circular metal manhole cover resting on a concrete slab. The slab is surrounded by green grass and some low-lying green bushes. The manhole cover has some markings on it.	<p>Typical open throat structure.</p> <p>Structure appears to be in overall good condition and functioning as intended.</p> <p>Owner should keep throat unobstructed and free of debris to ensure future proper operation of system.</p>

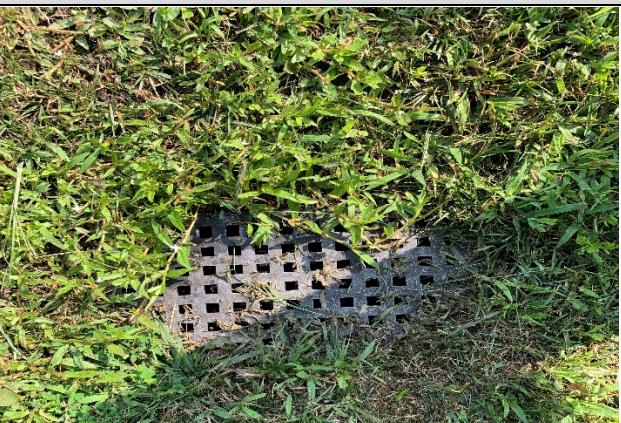
Picture 18	Notes

Picture 18 shows a typical yard inlet. It features a metal grate with a diamond pattern resting on a concrete slab, which is surrounded by green grass.	<p>Typical yard inlet.</p> <p>Yard inlet appears to be in overall good condition and functioning as intended.</p> <p>Owner should keep grate unobstructed and free of debris to ensure future proper operation of system.</p>

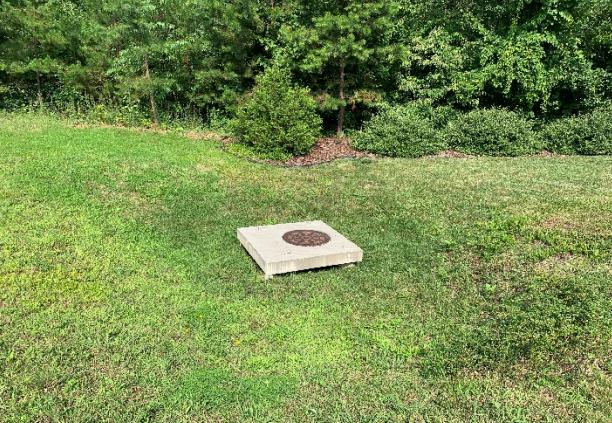
Picture 19	Notes

<p>Typical open throat structure.</p> <p>Structure appears to be in overall good condition and functioning as intended.</p> <p>Owner should keep throat unobstructed and free of debris to ensure future proper operation of system.</p>
Picture 20	Notes

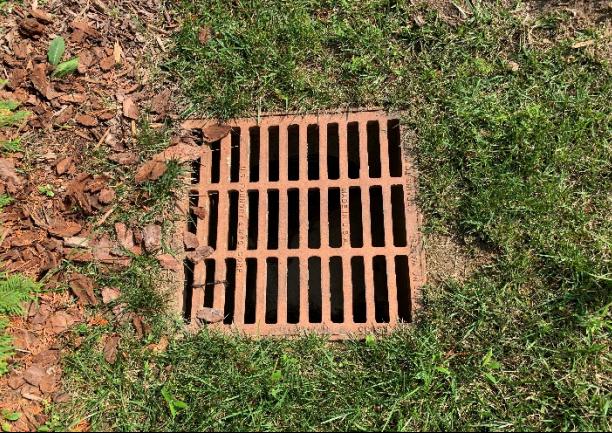
<p>Typical yard inlet.</p> <p>Yard inlet appears to be in overall good condition and functioning as intended.</p> <p>Owner should keep grate unobstructed and free of debris to ensure future proper operation of system.</p>
Picture 21	Notes

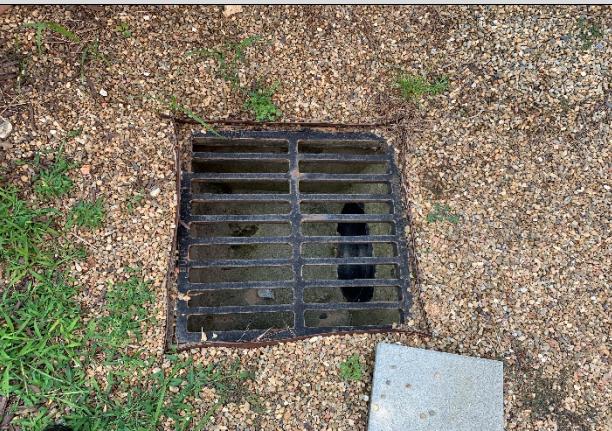
<p>Typical yard inlet.</p> <p>Yard inlet appears to be in overall good condition and functioning as intended.</p> <p>Owner should keep grate unobstructed and free of debris to ensure future proper operation of system.</p>
