Buncombe County Storm Water Operation Maintenance Inspection Report

Stormwater Permit No. S- 2014-0008

Subdivision Name/Lot Owner: Lakeside Meadows Subdivision

Project: 12400	Project Name: Lakeside Meadows	Observer: JSS
Date: 04/21/2024	Weather: Sunny	Time: 1:30 P.M.

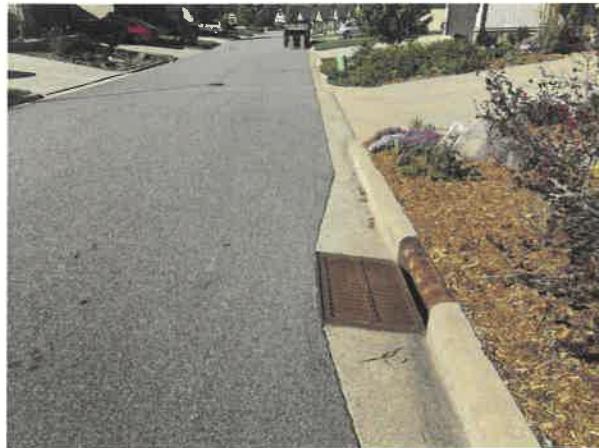
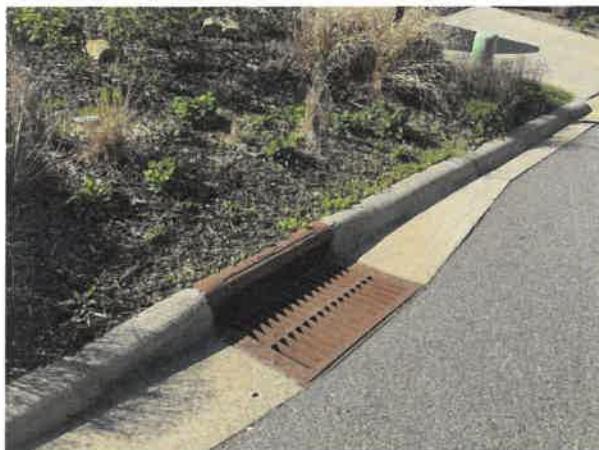
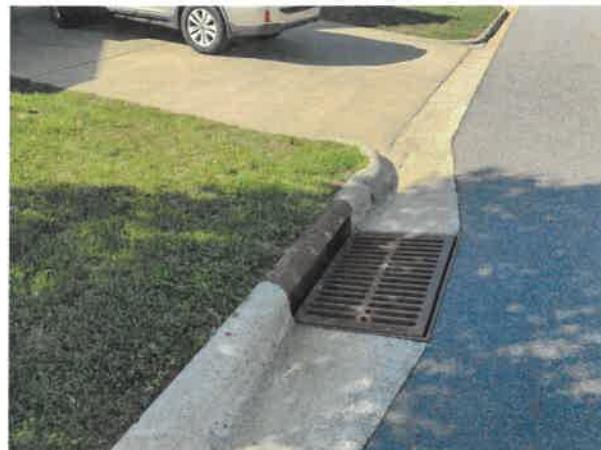
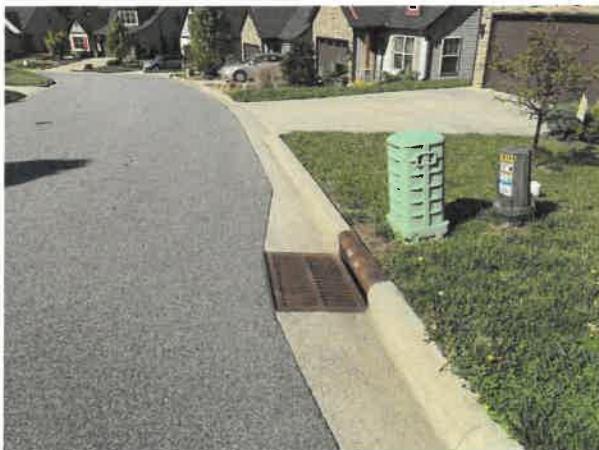
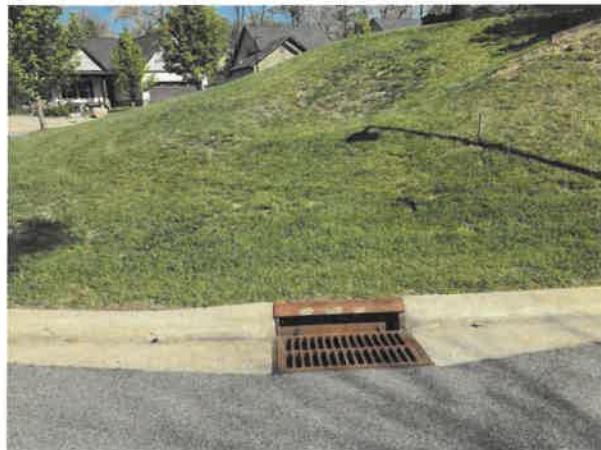
**Picture 1-5:**

- Pictures #1-5 are representative examples of the curb inlet frame and grates.
- The inlets are free of debris and appear to be functioning as intended.
- Owner should keep the area clean to ensure proper operation of the system.

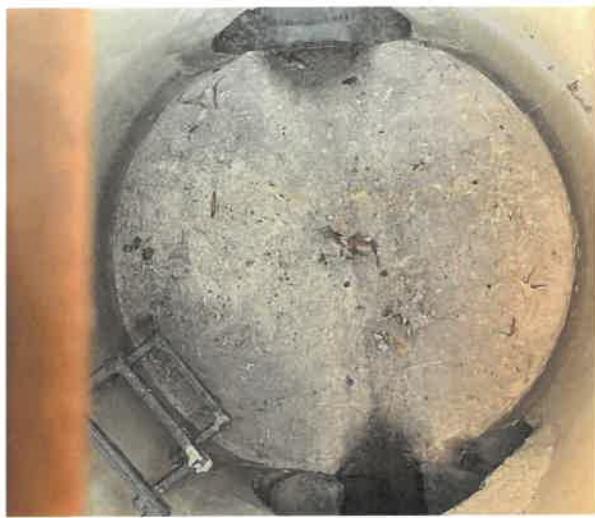
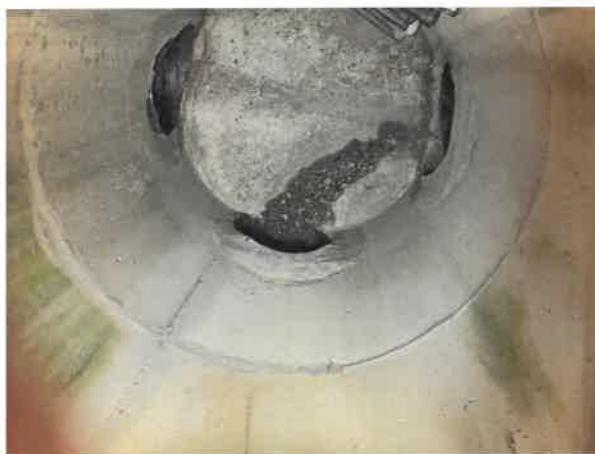
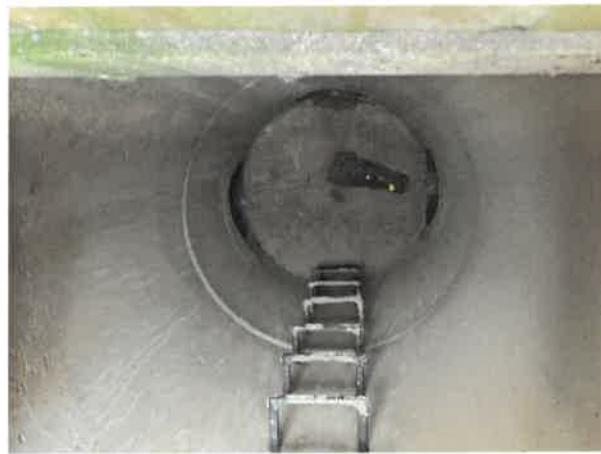
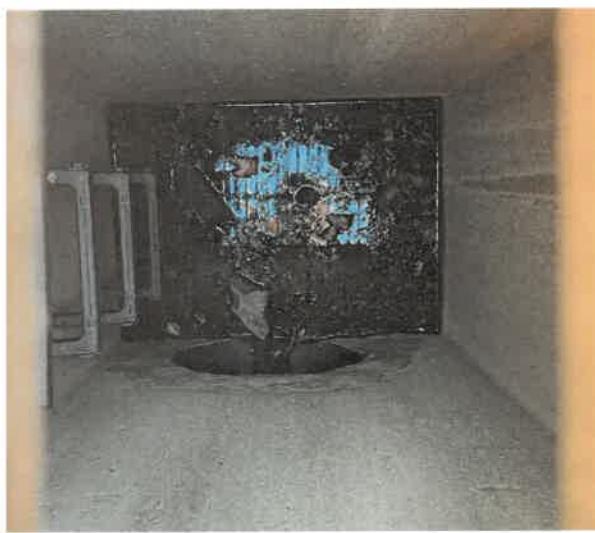
Picture 6-10:

- Pictures #6-10 are representative examples of the current conditions inside the stormwater structures across the site.
- The structures appear to be functioning as intended.
- The structure in photo #10 has rocks, as well as vegetative debris on the inside.
- It is recommended to remove the debris to ensure proper proper operation of the system.

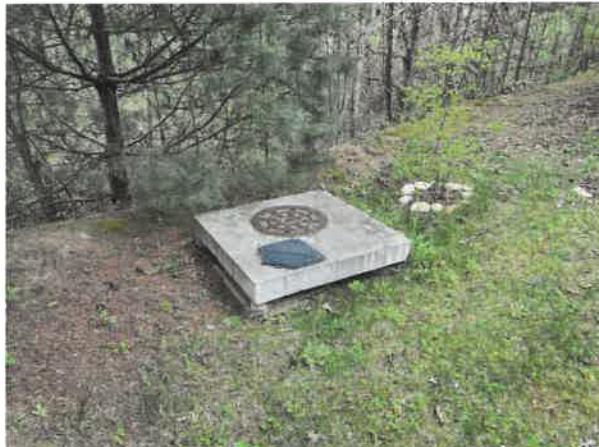
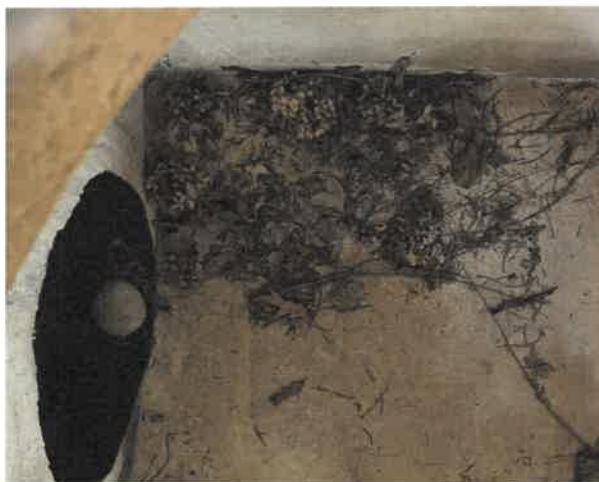
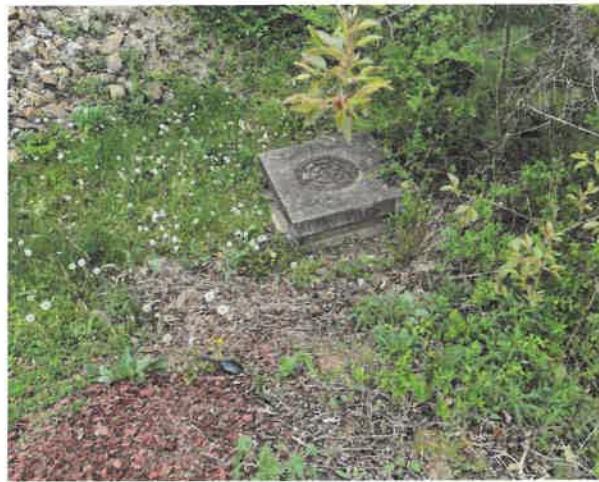
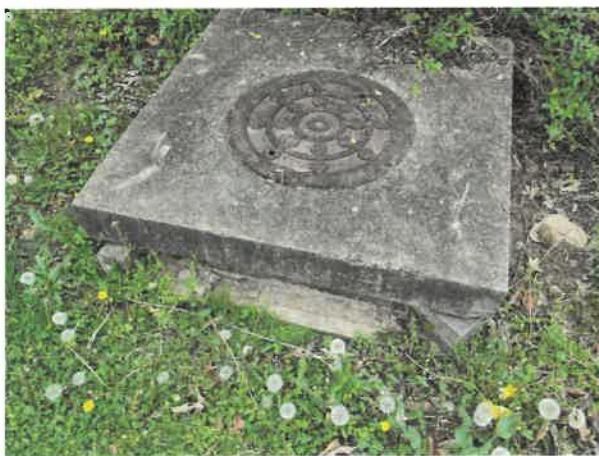
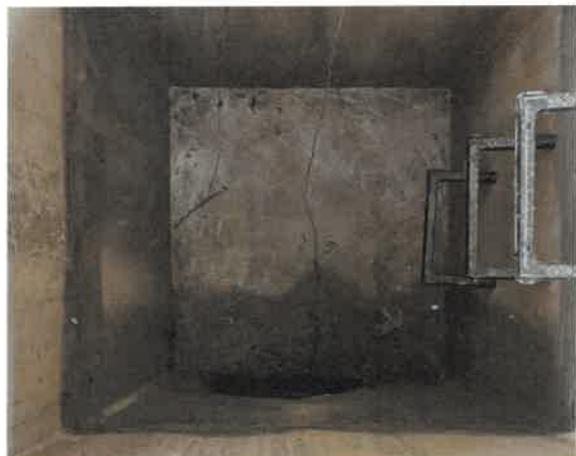
Picture 11-15:

- Pictures #11-15 are representative examples of the open throat structures across the site..
- Owner should keep the area clean to prevent debris entering the system to ensure proper operation.
